CONNECTICUT

Regional Transportation Safety Plan

NORTHWEST HILLS

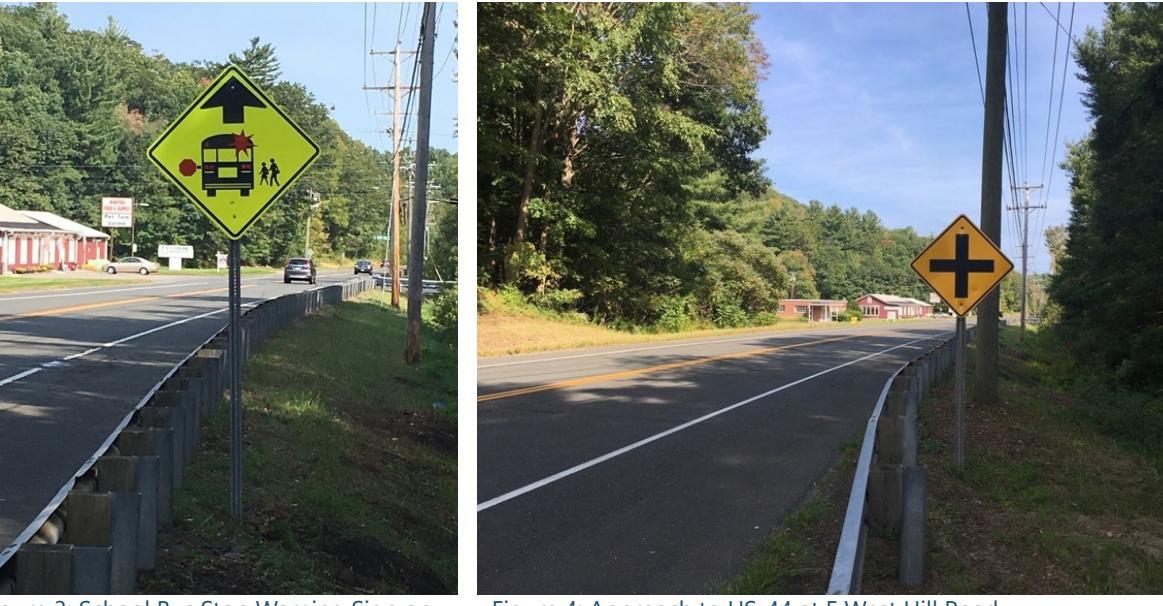
Figure 3: School Bus Stop Warning Sign on US-44 facing east

The adjacent land is mixed-use, commercial, private, open space, and residential. Moderate traffic for off-peak hours was observed. The presence of a school bus warning sign indicates a school bus stop (Figure 1).

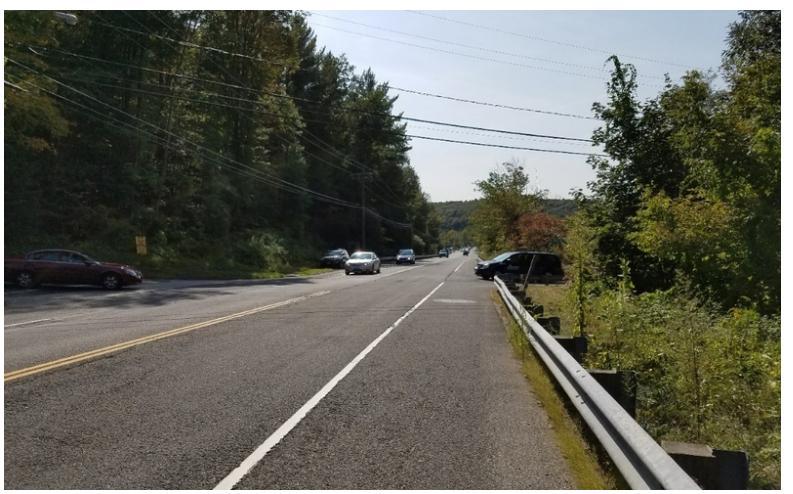
Figure 5: US-44 at W. West Hill Road, facing west

This is a four-way intersection with W. West Hill Road. The side streets are stop controlled (Figure 4). The southern leg of W. West Hill Road approaches US-44 at a steep down grade of over 12 percent (Figure 4). The posted speed limit of US-44 through this intersection is 50 mph. The adjacent land is mixeduse, commercial, private, open space, and residential. Moderate traffic for off-peak hours was observed, including truck traffic.

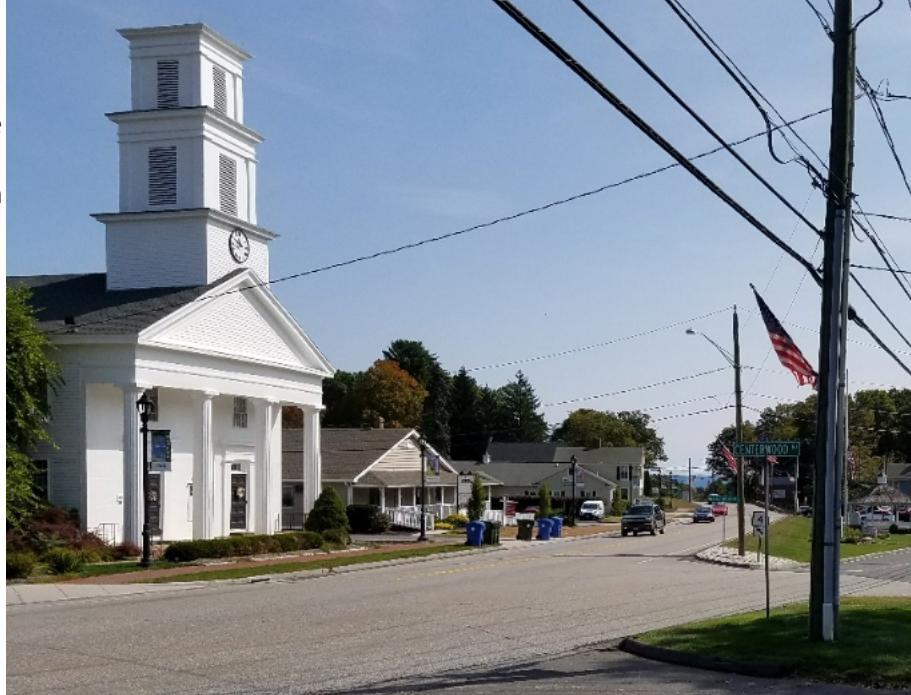
Figure 8: Burlington CT-4 and Savarese Lane

Sightlines from the George Washington Turnpike approach are limited due to the sharp skew of the intersection. The intersection of CT-4 and Savarese Lane also presents challenging sightlines for motorists entering CT-4 due to the vertical curvature along the Savarese Lane approach. At the intersection of Savarese Lane and George Washington Turnpike, the westbound traffic on George Washington Turnpike is not stop controlled, while the other three legs of the intersection are stop controlled. The posted speed limit for this section of CT-4 is 30 mph, however much higher speeds were observed. The adjacent land is mixed-use, historical, commercial, private, open space, and residential. Moderate traffic for off-peak hours was observed, including truck traffic.

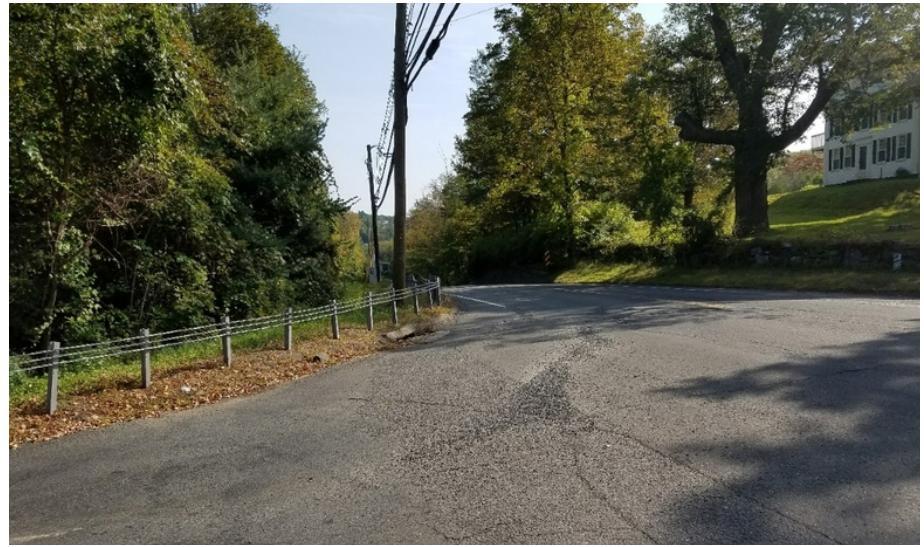
Figure 9: Barnes Hill Road approach to CT-4

Adjacent land use is residential. Moderate traffic for off-peak hours was observed, including truck traffic.

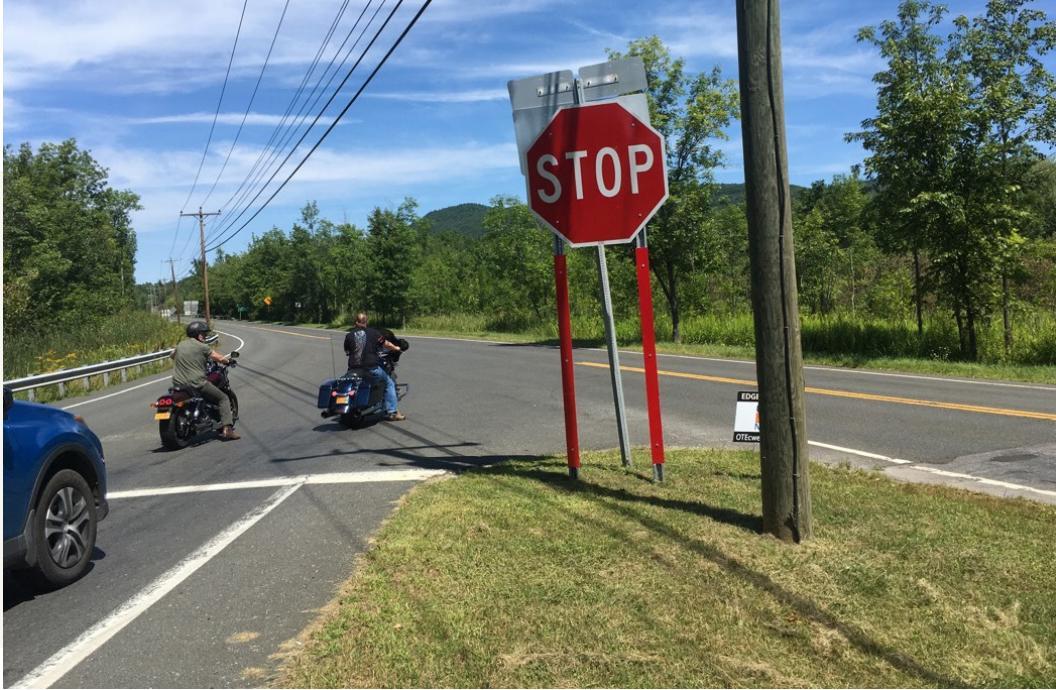
Figure 15: Intersection of US-7 and CT-63

There is one stop sign on northbound US-7 at the junction with CT-63. This intersection has limited sight distance and inadequate turning radius. Many vehicles opt to take Barnes Road where sightlines and turning radius are optimal. From our observations, the eastbound to northbound curve of US-7 could be removed, rerouting vehicles to intersection of CT-63 and Barnes Road.

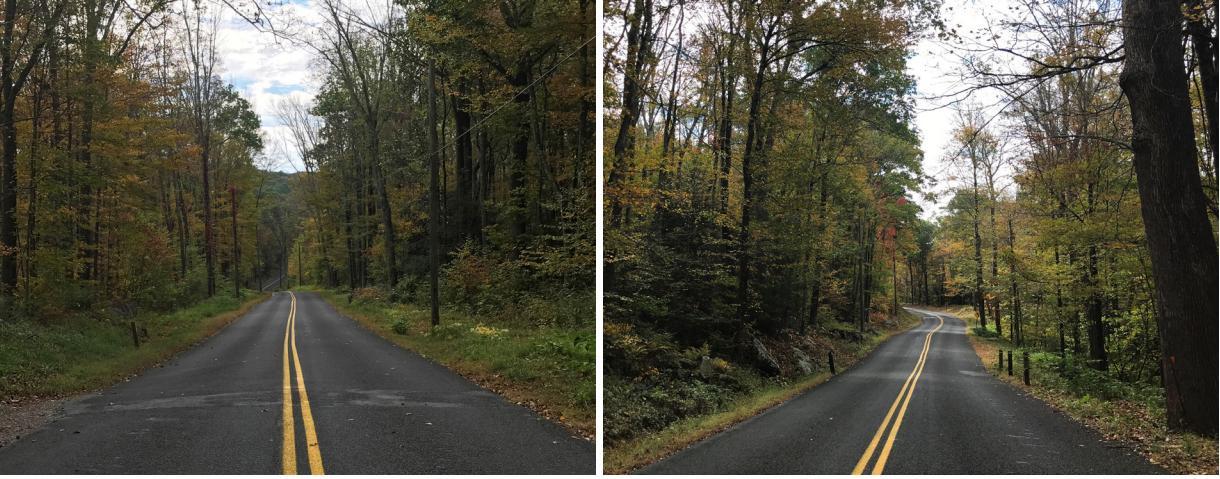
Figure 45: Horizontal and Vertical Curvature on Plymouth Road

Plymouth Road is classified as a local road south of CT-4. Horizontal and vertical curvature limit the sight distance along this road. Vehicles frequently travel at speeds higher than the posted limit of 30 mph. The current chain and post guiderails along this segment are not up to current standards. The pavement and centerline marking are in new condition. There are no edge lines, paved or unpaved shoulders present.

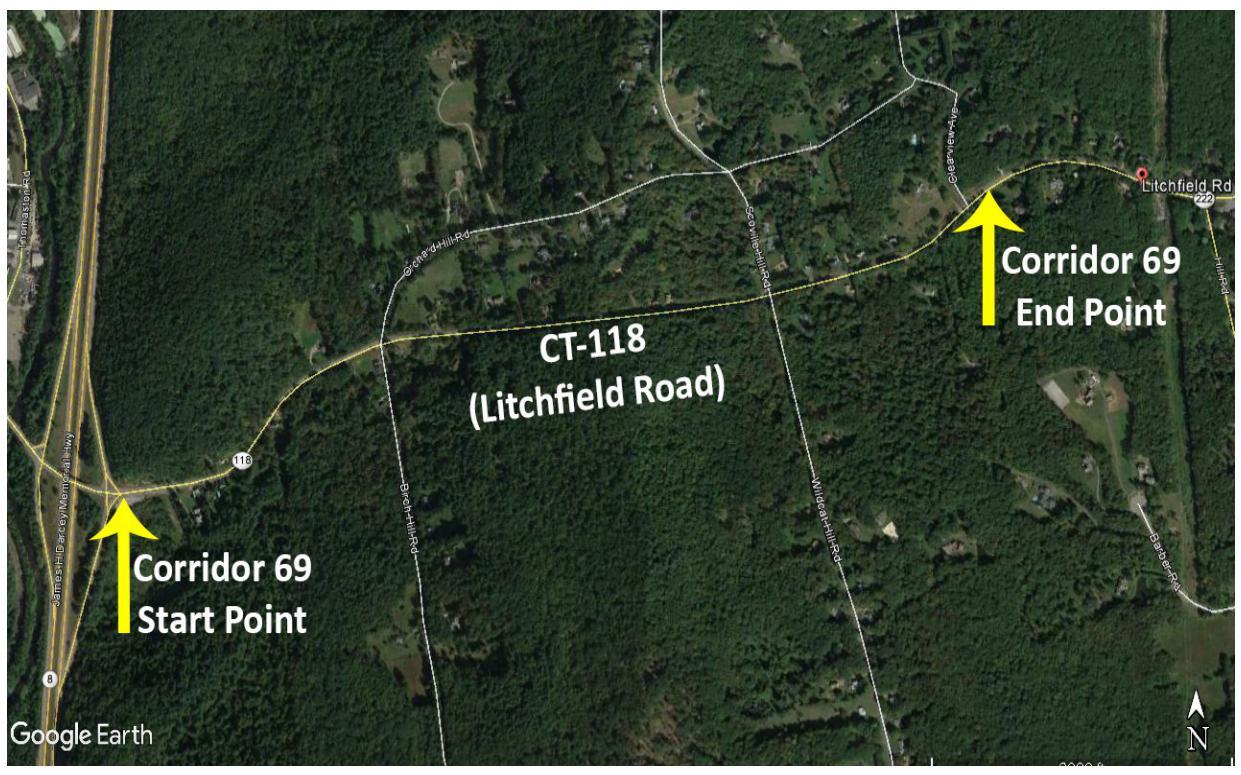
Figure 47: CT-118 Aerial View

Drivers on CT-118 were observed speeding near CT-8. There is horizontal and vertical curvature along the corridor. Traffic volume was moderate at the time of study. Pavement and pavement markings are in fair condition. Sight distance was adequate due to no significant curvature or overgrown vegetation. There are three points where Corridor 69 meets local roads with no signage in place to warn vehicles of approaching intersections. This segment also intersects with CT-8 onand-off ramps. There is no lighting in place for any of these intersections.

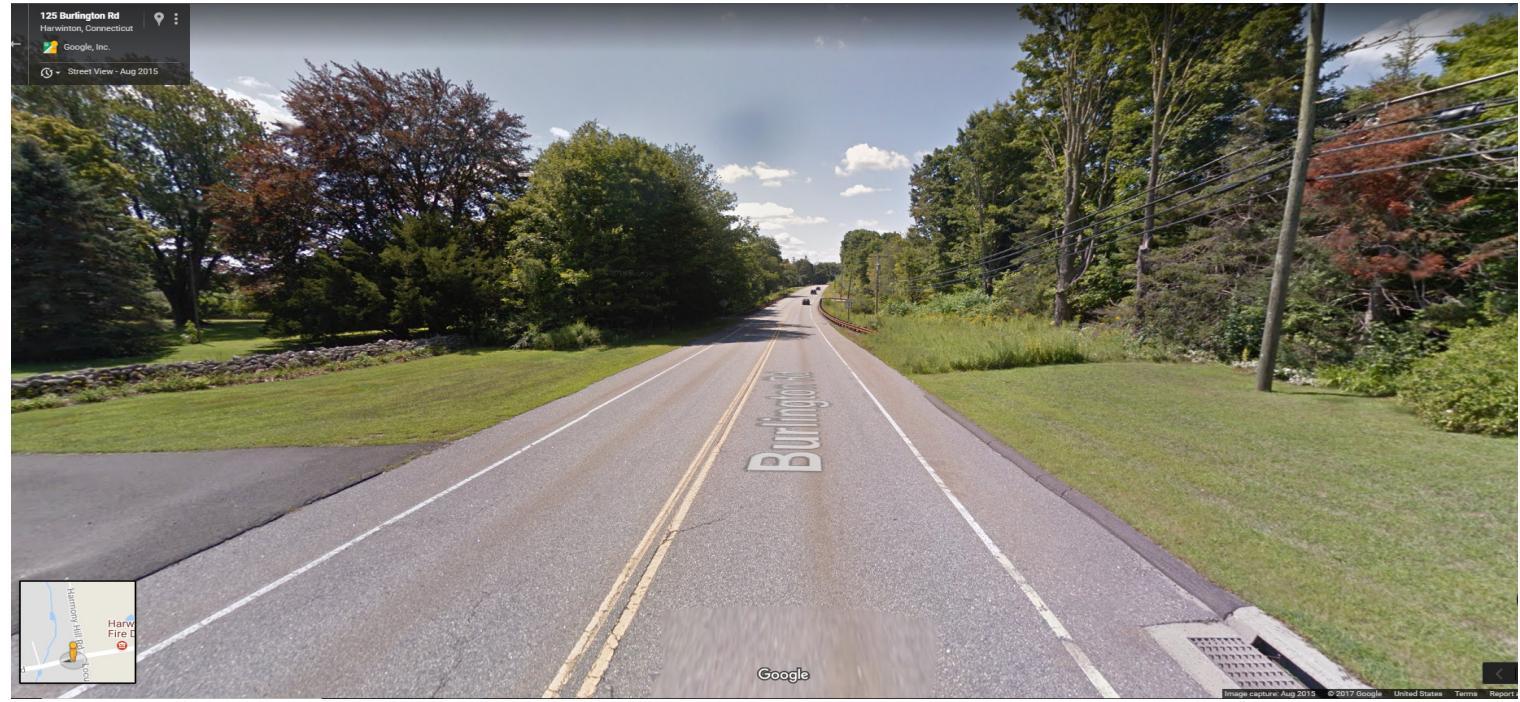
Figure 50: CT-4

Corridor 70 has continual vertical curvature along the entire segment. There are driveways along this corridor with some being obscured from view due to vegetation. Two local roads and one neighborhood intersect with **Corridor 70**. Vehicles were observed speeding higher than the posted limit of 40 mph. The pavement and pavement markings are in fair condition.

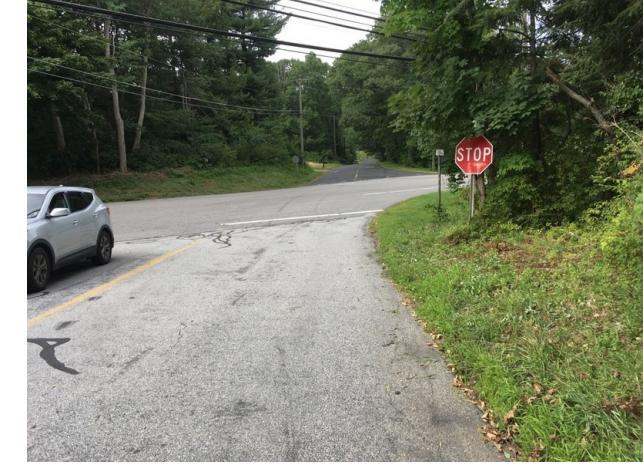
Figure 63: Fern Avenue and US-202

This corridor's steep vertical curvature results in limited sightlines. There is a climbing lane exclusively in the eastbound travel lane that ends west of the nursery. This roadway design presents hazards associated with the limited sight distance, coupled with vehicles accelerating for positioning prior to the termination of the extra lane. The moderate traffic volume, with high heavy truck volume was observed to exceed the posted speed limit of 45 mph along this corridor. The existing stop control consists of one stop sign in fair condition for vehicles approaching US-202 from Fern Avenue and one for vehicles approaching from Town Farm Road. There are centerline rumble strips along this corridor.

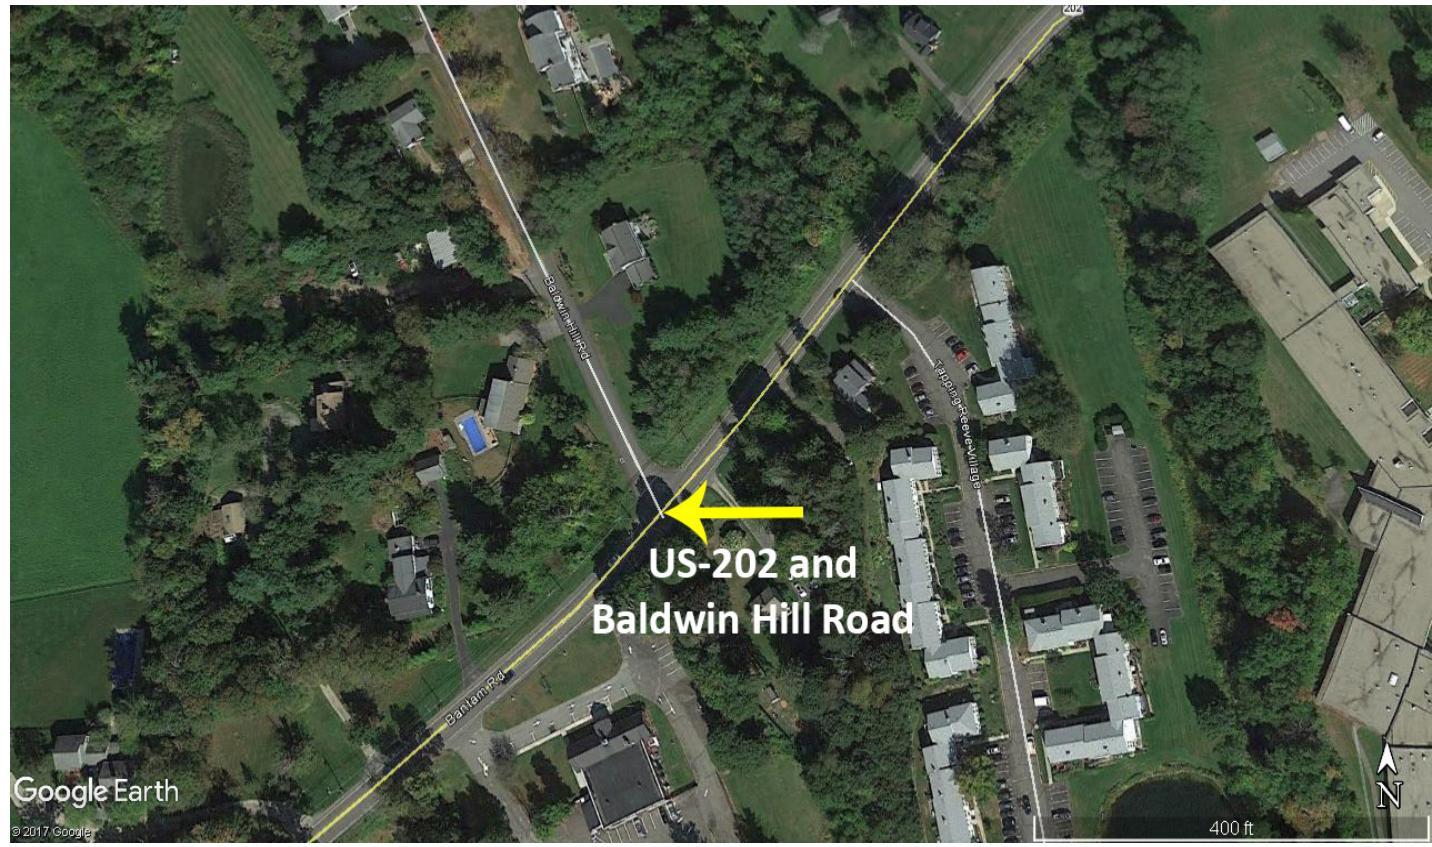
Figure 67: Aerial View of US-202 and Baldwin Hill Road

Limited sight distance, vegetation, speeding and curvature on US-202 are a challenge for motorists exiting Baldwin Hill Road. The turning radius is inadequate for vehicles turning left onto US-202 or right onto Baldwin Hill Road. From visible roadway damage, it is apparent that trucks require a wider turning radius than exists currently. Traffic and truck volume is heavy in this area. Edge lines are in poor condition. The stop bar for vehicles approaching US-202 from Baldwin Hill Road has weathered away and needs to be replaced. Although the traffic data within this report's study period does not highlight this location, the Town is concerned about this intersection.

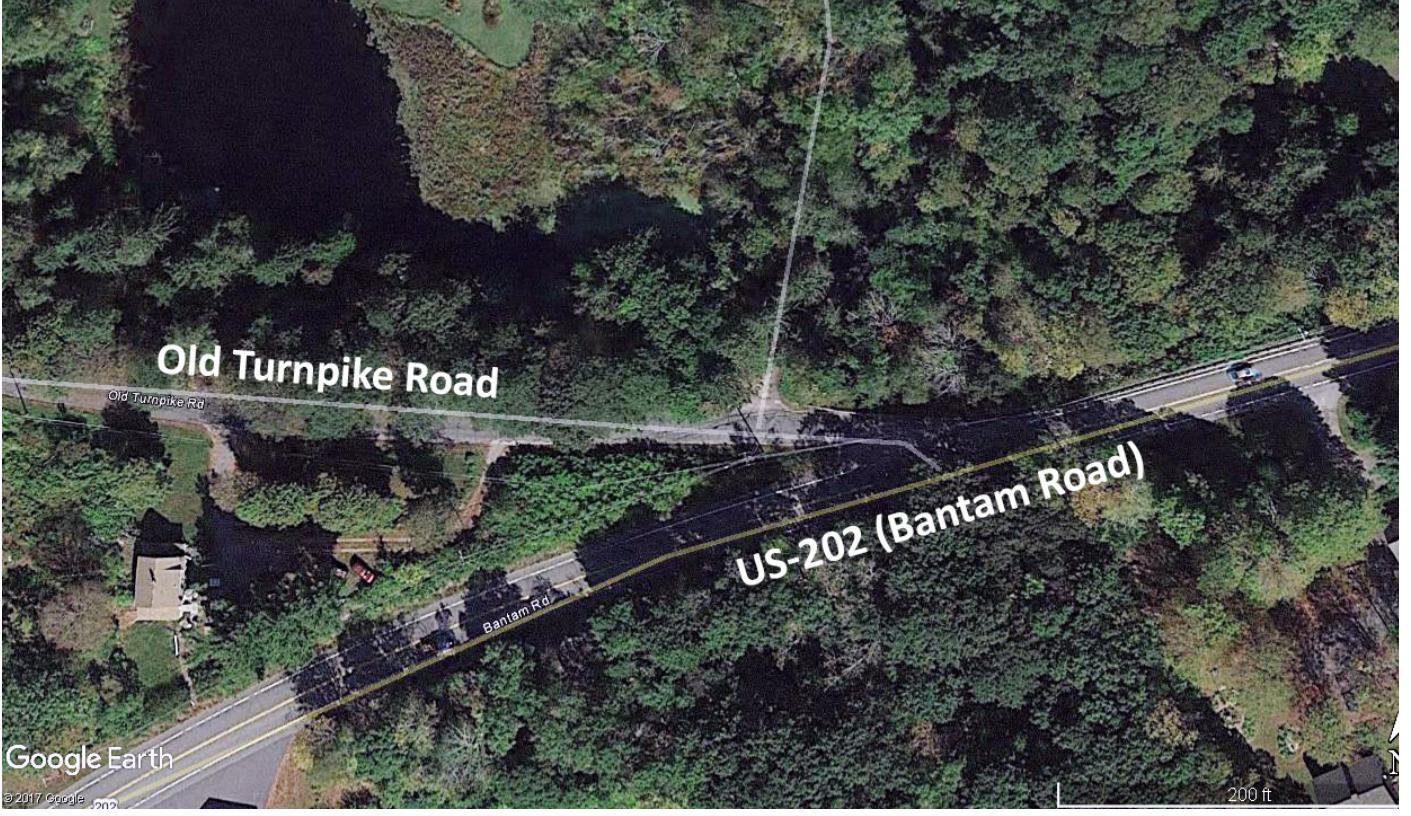
Figure 68: Aerial View of US-202 and Old Turnpike Road

Vegetation near the stop sign of the intersection impedes visibility. Vehicles were observed traveling at high speeds along this section of US-202. Wood post bollards adjacent to the roadway should be considered for removal. The turning radius for motorists heading west onto US-202 is undesirable. Old Turnpike Road has a steep side slope leading into a four-foot-deep ditch.

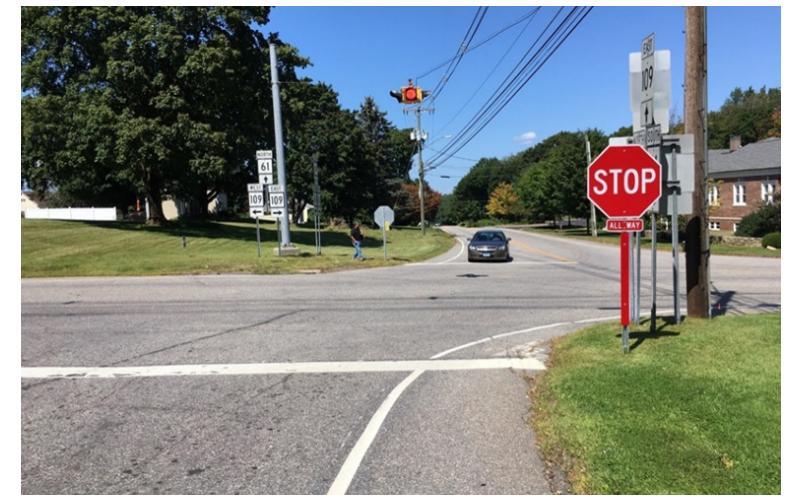
Figure 78: Intersection of CT-109 and CT-61

Fieldwork was conducted with the assistance of the First Selectman. The intersection of CT-109 and CT- 61 is at the edge of data-drivenCorridor 61. This is a four-way stop controlled intersection with a flashing red signal (Figure 77). Observed traffic included heavy trucks, pedestrians, cyclists, and automobiles. Pedestrian volumes were low at the time of the visit; however, conflicts with vehicles were observed, primarily due to disregard of stop-control devices. Vehicles running stops were observed during fieldwork and reported as a common occurrence. In addition, CT-61 is offset so vehicles must turn while crossing oncoming traffic. Furthermore, as opposed to current practices that narrow the roadway at intersections, the northeast and southwest corners flare at these intersections to accommodate truck traffic (Figure 78).

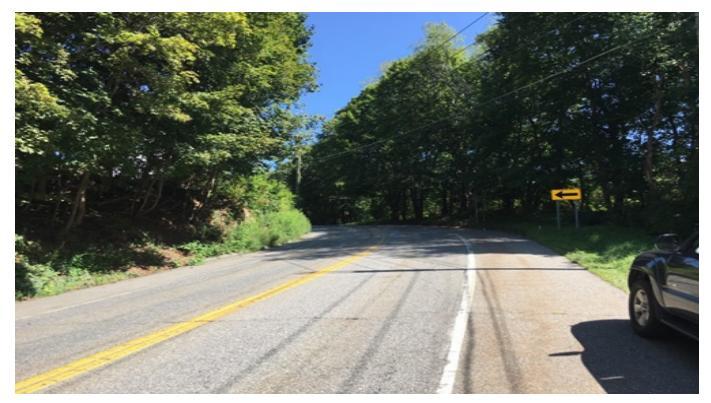
Figure 79: CT-109 Curvature Combination

The field investigation found guide arrow sign and guiderails in poor condition. Physical elements include heavy tree canopy, horizontal curvature, and steep vertical curvature (at roughly 9% grade), all of which contributed to the inadequacy of the sight distance (Figure 80). Moderate traffic with heavy trucks and cyclists were present during the field visit.

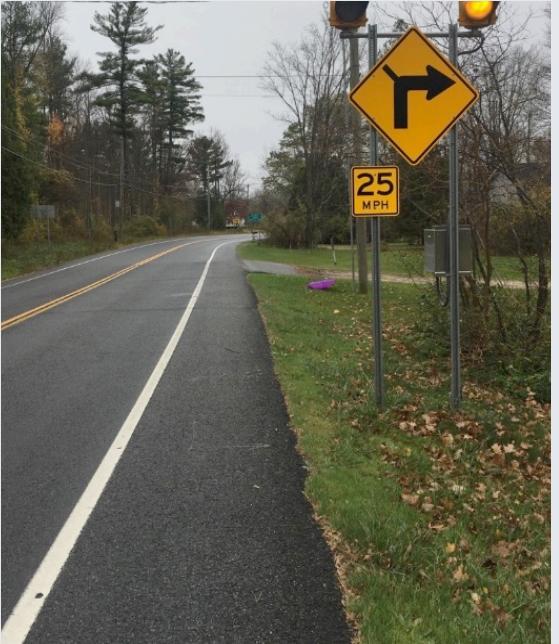
Figure 98: Horizontal alignment sign with Advisory Speed sign

The other priority for the Town is the western section of US-44 from Raymond Avenue to the Salisbury Town line. This segment has horizontal curvature and the road is at a slope according to Town Representatives. Another roadway hazard is oil spills, which is common along this route due to the high-volume of heavy truck traffic. Two major companies, Rebar Transportation and Specialty Minerals, contribute to the high volume of freight traffic generated within the Town.

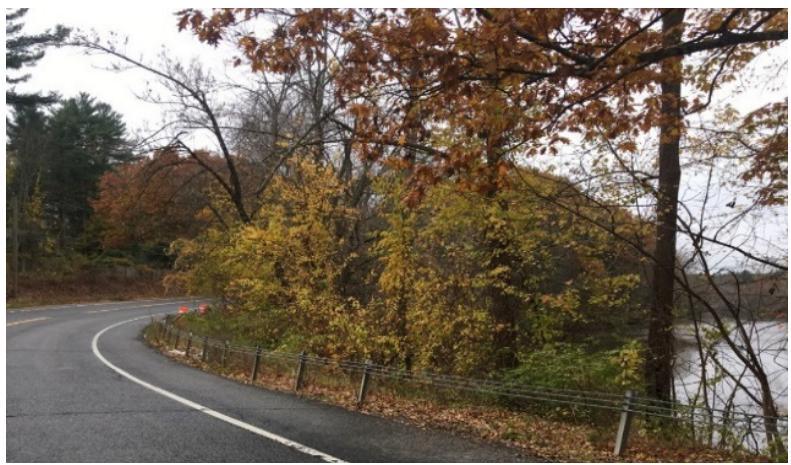
Figure 100: US-44 at Lawrence Avenue

This segment of US-44 between New High Street and Honey Hill Road has moderate to severe horizontal curvature. This section is located along the Housatonic River. The current protection system is a cable guiderail structure (Figure 101). The Town noted there had been a fatality along this stretch and stated that under wet conditions it is quite hazardous.

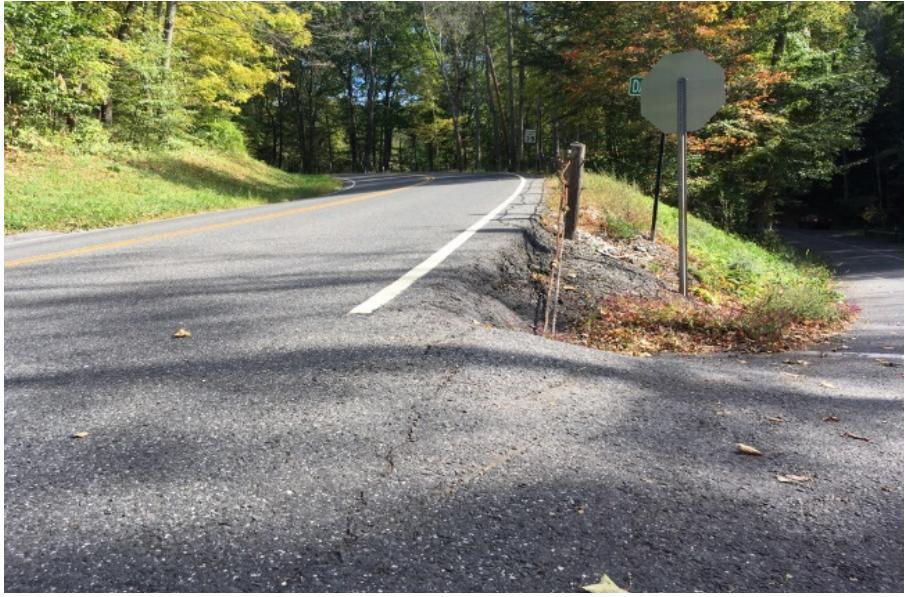
Figure 111: CT-199 North of Davenport

This segment of CT-199 has steep vertical and horizontal curvature which impedes sight distance in both directions. Motorists turning from Davenport Road or Battle Swamp Road do not have adequate sight distance to turn onto CT-199. There is significant elevation disparity between Davenport Road and CT-199 which further exacerbates the inadequate sight distance. The road has centerline and edge pavement markings. There are no curve warning signs. The guiderail protection system is composed of wood beams and cables. Drivers were noted travelling at high speeds.
